Docket No. 217 – Development and Management Plan Inspection

Northeast Utilities Service Company Certificate of Environmental Compatibility and Public Need for the construction of a 345-kV electric transmission line and reconstruction of an existing 115-kV electric transmission line between Connecticut Light and Power Company's Plumtree Substation in Bethel, through the towns of Redding, Weston, and Wilton, and to the Norwalk Substation in Norwalk, Connecticut.

Date: August 16, 2006

Location: 115 kV Underground Route

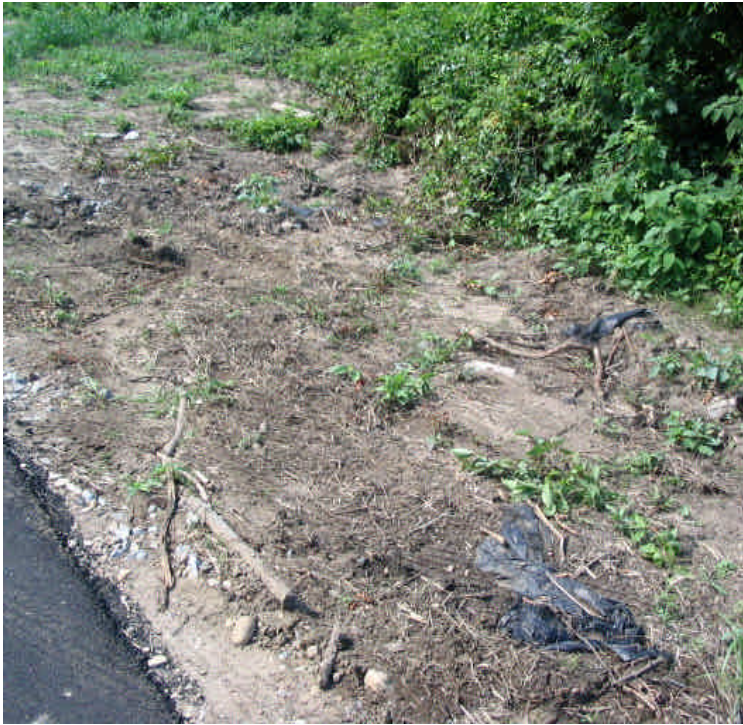
Photo on the left shows a view of the previously restored area adjacent to the bike path on Broad St. Old silt fence was buried during the restoration and should be removed. Photo on the right shows the erosion control mat previously placed along the slope at the Bethel Ed Park near the south tower. 8/16/06

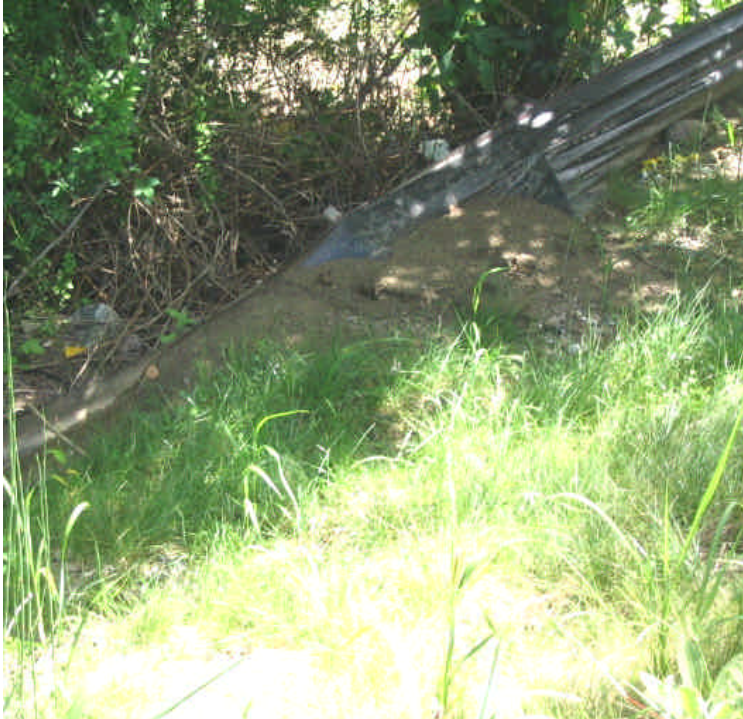
Photo on the left shows the washout remaining along the slope near the south tower, adjacent to where the EC mat was installed. Photo on the right shows grass growth returning in the restored areas along the driveway to the transition structure. 8/16/06

Areas of Inspection	Observation	Recommended Action	Corrective Action
Active Work	- Bethel Educational Park: - A piece of erosion control mat was installed on the southern slope but a small washout remains. 7/26-8/16/06	-The washout is minor but sediment has piled up along the silt fence. See EC section. 8/16/06	-Still needs attention when feasible
Rt. 107, Redding	-Final roadway work was noted as crews were grinding down the surface and repaving along the roadway. 8/16/06	- None at this time. 8/16/06	- N/A
Rt. 58, Bethel	-No work was noted. 8/16/06	-None at this time. 8/16/06	- N/A
Broad Street/ROW, Norwalk	-The restored areas adjacent to the bike path had some silt fence debris under the soil. 7/12-8/16/06	-Carefully remove all old silt fence and debris from this area. 7/12-8/16/06	-Needs attention
Main Ave. / Rt. 7, Norwalk	-None at this time. 8/16/06	-None at this time. 8/16/06	-N/A
Erosion and Sediment Controls Bethel Education Park	- One washout remains at the slope of the BEP south tower where sediment is building up at the fence. 7/19-8/16/06	- The washout is minor but another piece of erosion control mat would likely stabilize the area. 8/16/06	- Needs attention when feasible

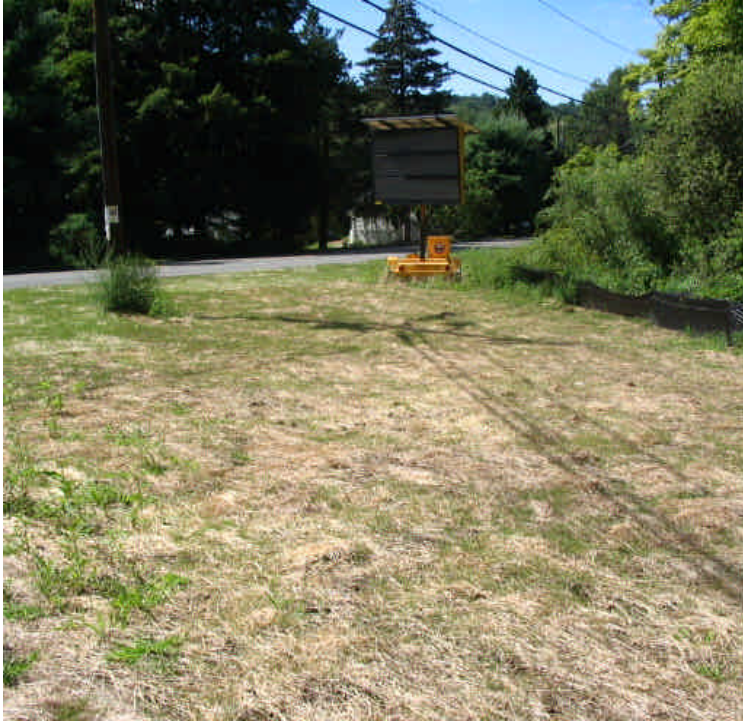
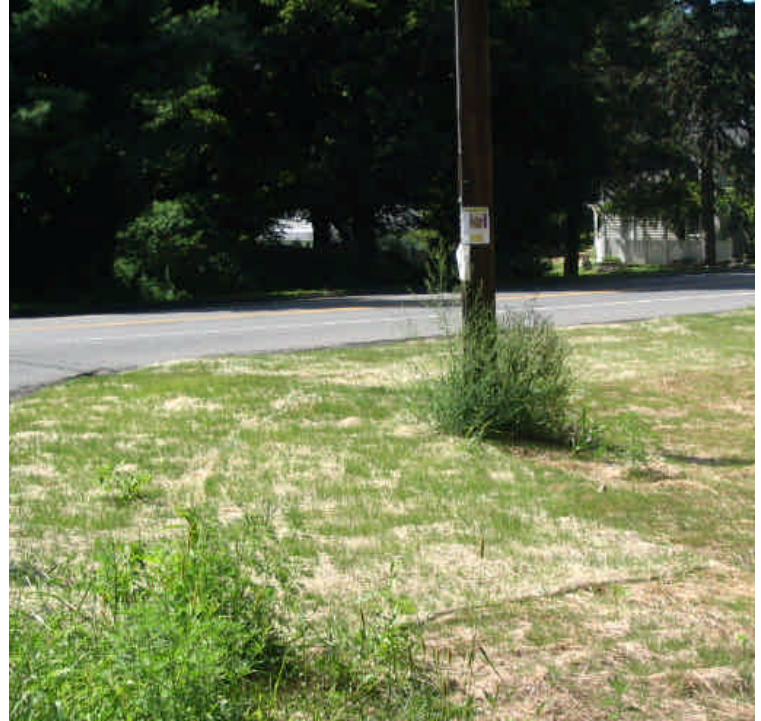
Both photos show views of the Sunset Hill Rd storage area. The recently restored area with the erosion control mats and seed and mulch continues to have increased vegetative growth. 8/16/06

- At Sunset Hill Rd. vegetative growth continues at the mats. 8/16/06	- The entire area is now well restored. Continue to monitor. 8/16/06	-N/A
Rt. 107 (Lonetown Rd)	- The Redding CC storage area stone surface remains stable and controls are in good shape. 8/16/06	- None at this time. The area had been used for some additional parking but will be restored. 6/1-8/16/06	-Restore when feasible
Soils	-Large stockpiles are noted at the Putnam Park storage areas but are state jurisdiction. 8/16/06	- None. 8/16/06	-N/A
Adjacent Wetlands and Waterways	-All resource areas in the vicinity of the project are in good shape. 8/16/06	- None. 8/16/06	-N/A
Staging, Storage, and Parking Areas	-Most storage areas are now returned to the original landowner. 8/16/06	- The Sunset Hill storage area is in good shape. Look into final status at the Redding CC area. 8/16/06	- Evaluate Redding CC area
Vegetative clearing or stabilization	- Most areas are quickly becoming stabilized with increased vegetative growth. 4/12-8/16/06	-Continue to monitor but areas look good. 8/16/06.	-N/A

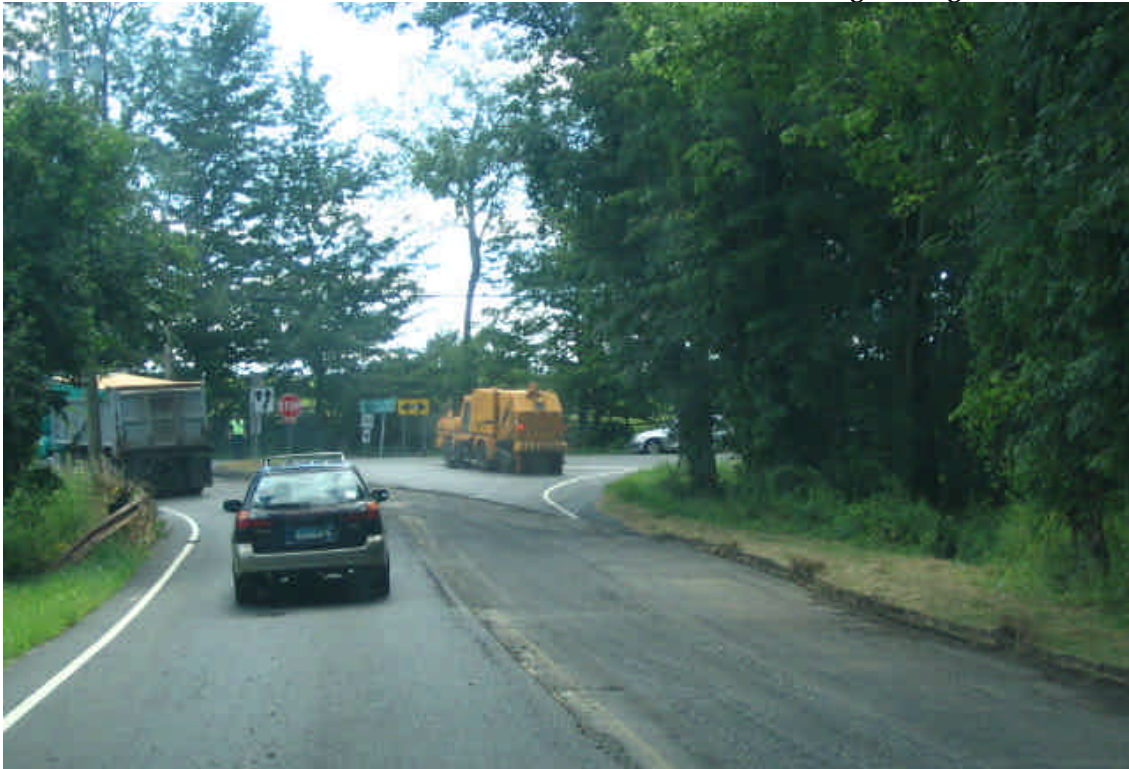
Photo shows a view of the roadwork remaining on the project along Rt 107. Crews were grinding the surface down and repaving. 8/16/06
